## **Rocklands Caravan Site - Evidence of Expansion of Car Parks, Roads and Vegetation Clearances.**

The aerial photos used in this document have been obtained from Google Earth and GetMapping. They provide a visual history of the developments at Rocklands from 1999 up to July 2013.

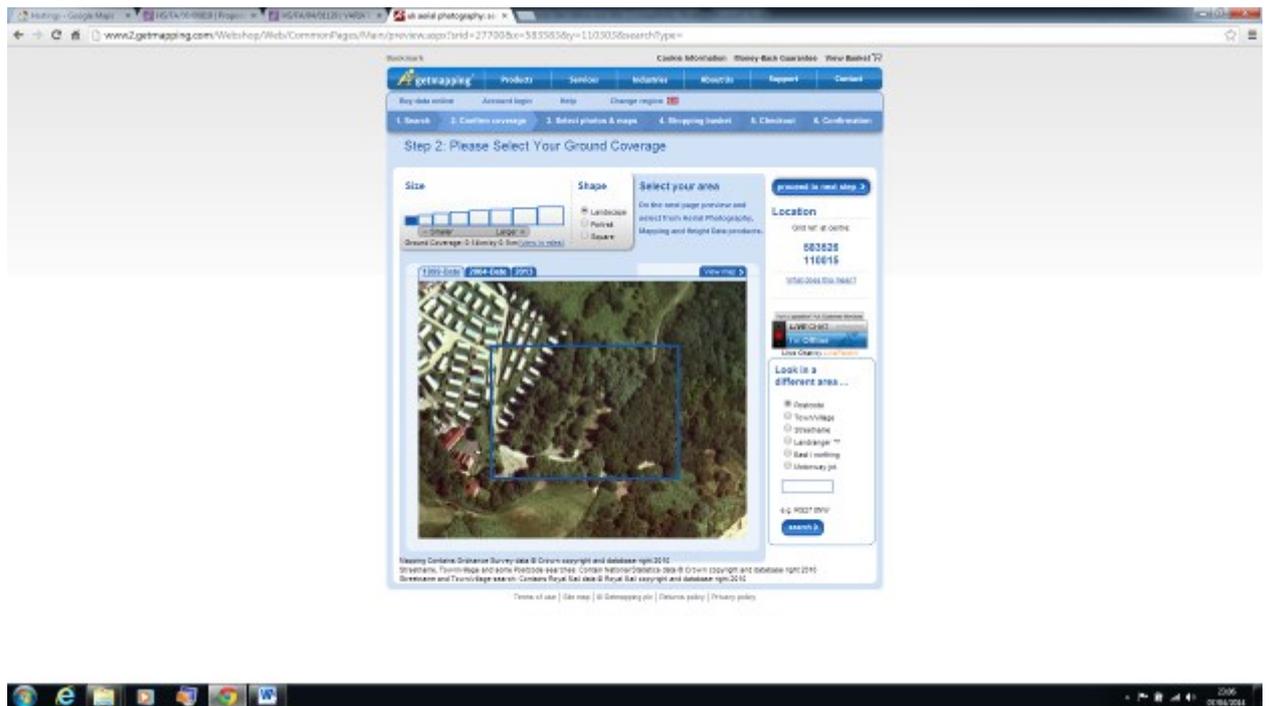
## 1999 GetMapping View

The bottom left hand corner of the blue square shows the existing car parking area at this date. The car park is roughly triangular with a narrow linking road exiting to the east which runs on for about 50 to 60 feet. This area of parking and road is well screened by trees to the south and was never visible from the other side of the glen.

The rest of the area within the blue square is a mixture of trees, bushes and grass.

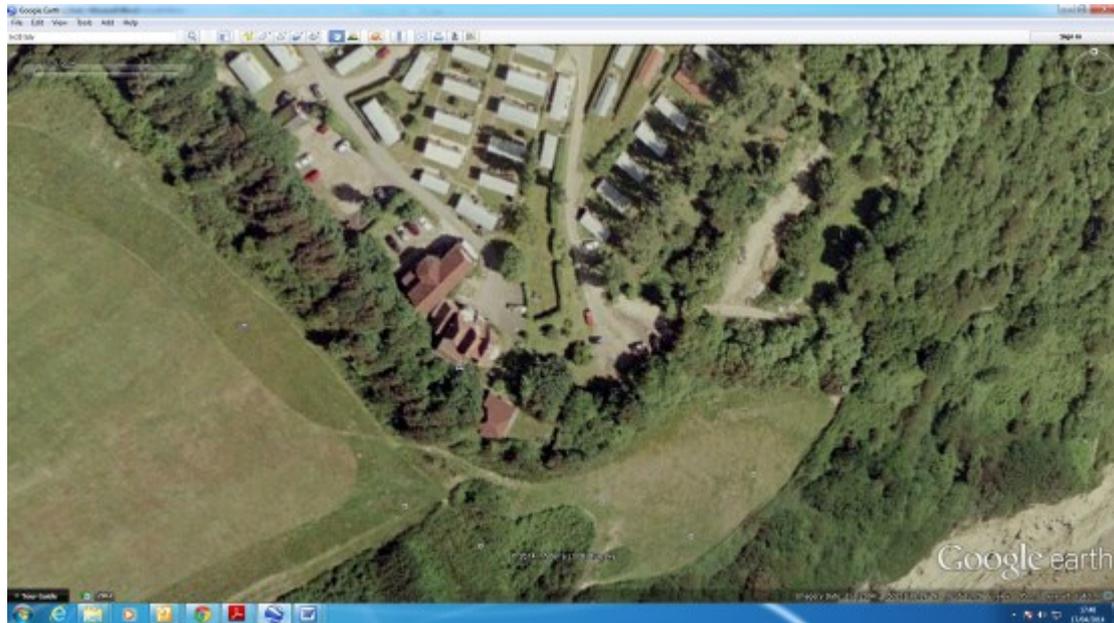
## 2004 Google Earth View

- A large strip to the North East of the triangular car park and due north of the narrow linking road has now been cleared of vegetation and is now bare earth.

- No Planning permission was sought for this change
- The landscaping changes breach condition 8 of HS/FA/78/00703
- The removal of trees breaches condition 4 of HS/FA/78/00703

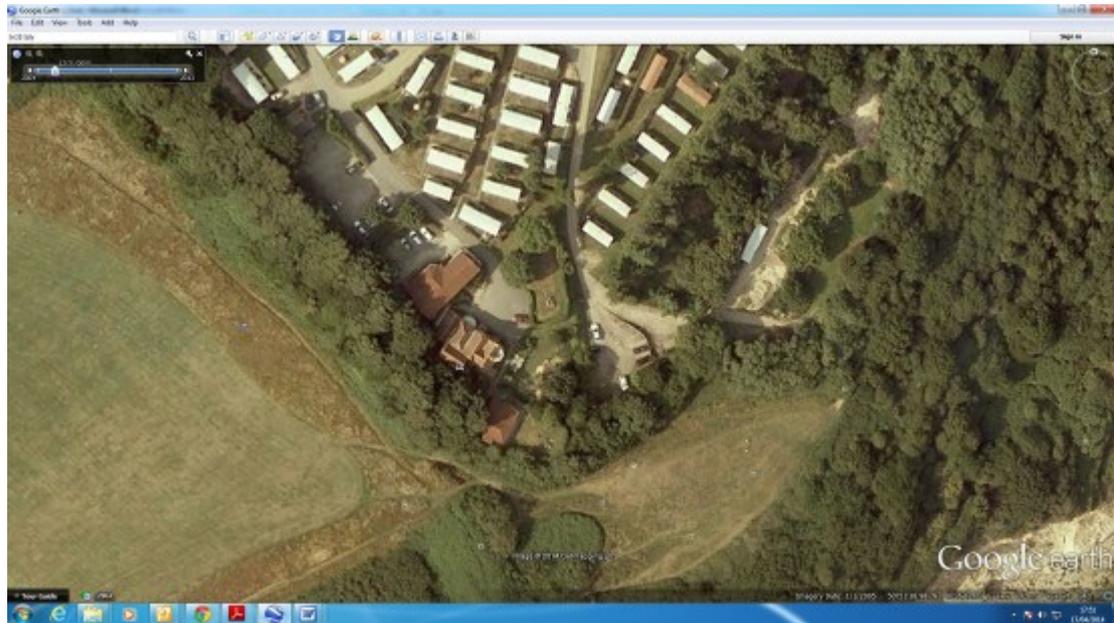
## 2005 Google Earth View

- There appears to be a low wall or barrier built down the middle of the car park. This feature could encourage funnelling of drainage water.
- The bare strip to the North East of the car park has been extended in length by about 30%.
- A caravan has been installed on the strip.

- No Planning permission was sought for these changes
- The landscaping changes breach condition 8 of HS/FA/78/00703
- The removal of trees breaches condition 4 of HS/FA/78/00703
- The installation of the caravan breaches condition 7 of HS/FA/78/00703

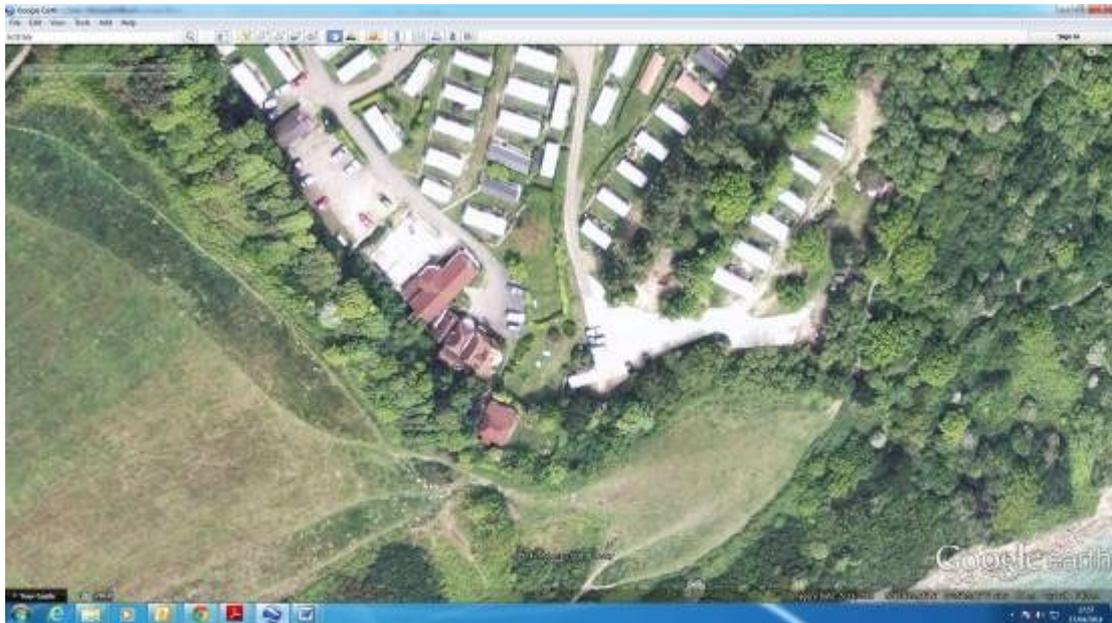
## 2009 Google Earth View 23/05/2009

- The bottom left hand side of the triangular car park has been extended westwards in a strip.
- An area to the north of the triangular car park has been cleared of trees.
- The bottom right hand side of the car park has been extended southwards.
- The narrow linking road has been doubled in width on its entire length.
- The narrow linking road is now part of an extended car park.
- The narrow linking road has been extended eastwards.
- The narrow linking road has now been concreted.
- 6 caravans have been installed. 50% of the trees in front of these caravans have been removed.
- There has been terracing to provide level ground for the new caravans.

- No planning permissions were sought for any of these changes.
- The installation of the 6 caravans breaches condition 7 of HS/FA/78/00703
- The removal of trees breaches condition 4 of HS/FA/78/00703
- The terracing breaches condition 8 of HS/FA/78/00703
- The extension of the car park and roads breaches condition 9 of HS/FA/78/00703

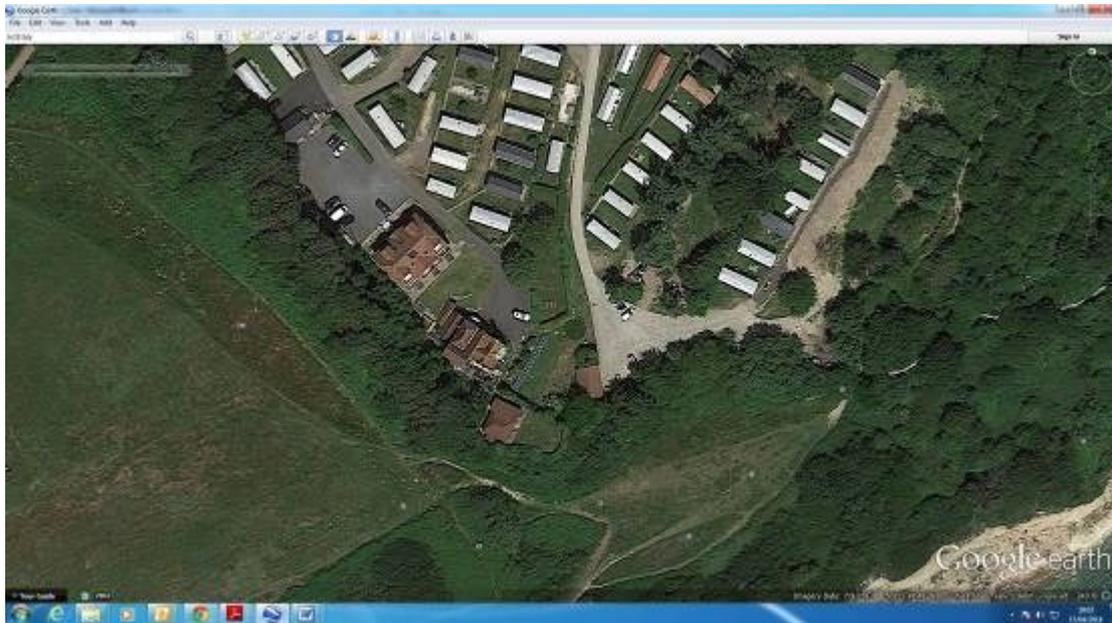
## 2013 Google Earth View - 09/07/2013

- There is a new building in the bottom left hand corner of the car park.
- The car park is now clearly marked with parking bays. It has possibly been resurfaced.
- There is a clearly visible landslide within the grounds of Rocklands at the eastern end of the linking road. This pre dates the large landslide of 2014.
- Only 1 tree now remains of the trees that used to grow in front of the new caravans.
- All other vegetation has been removed from in front of the new caravans.
- There are now 8 caravans in place.
- The land is being levelled for a new access road being constructed in front of the new caravans. The yellow digger which has been used for landscape changes is clearly visible.

- No planning permissions were sought for any of these changes.
- The installation of the 8 caravans breaches condition 7 of HS/FA/78/00703
- The removal of trees breaches condition 4 of HS/FA/78/00703
- The terracing breaches condition 8 of HS/FA/78/00703

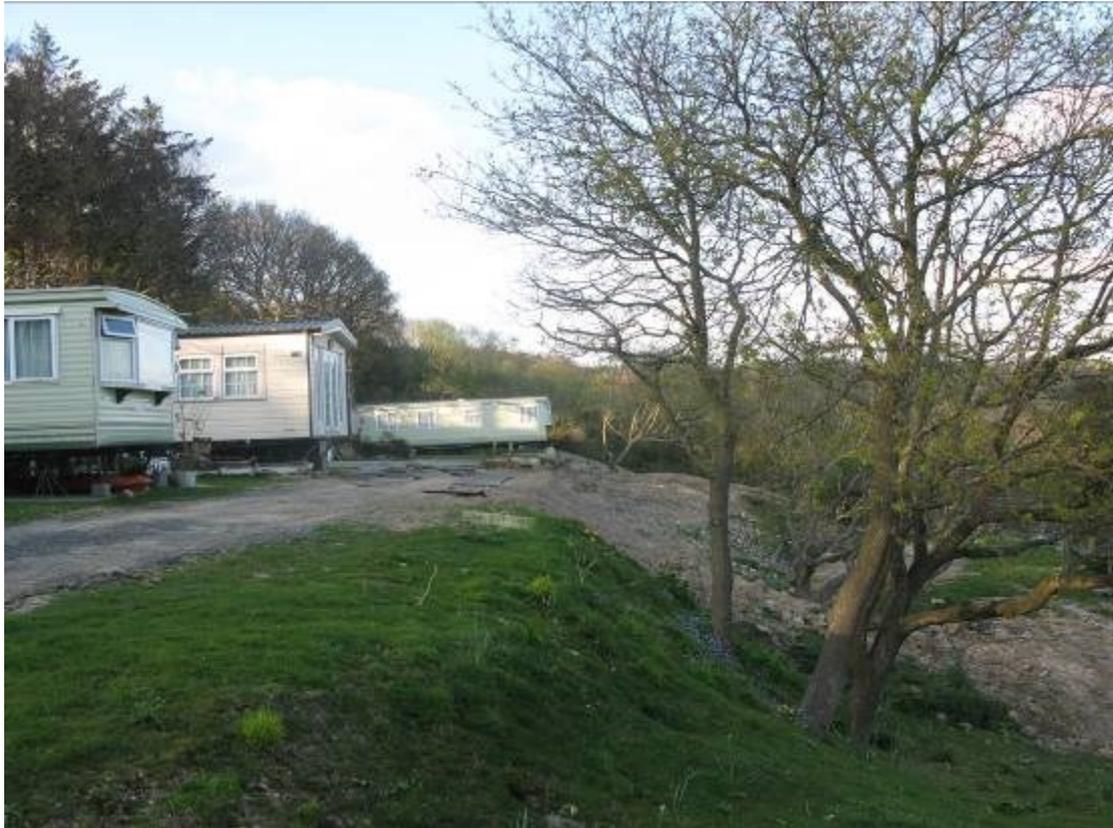
New road in front of caravans and terracing. Appears to be tarmac.

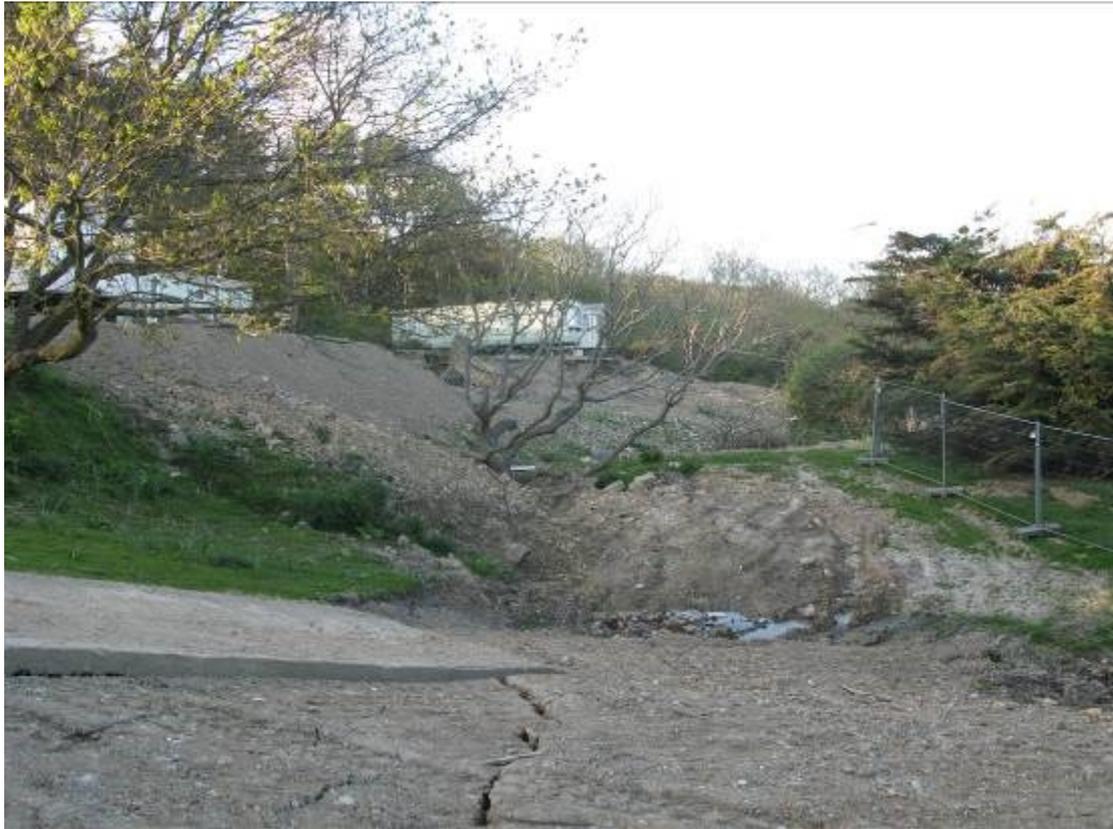
End of the concrete link road eastern extension. This is right next to the start of the landslip.

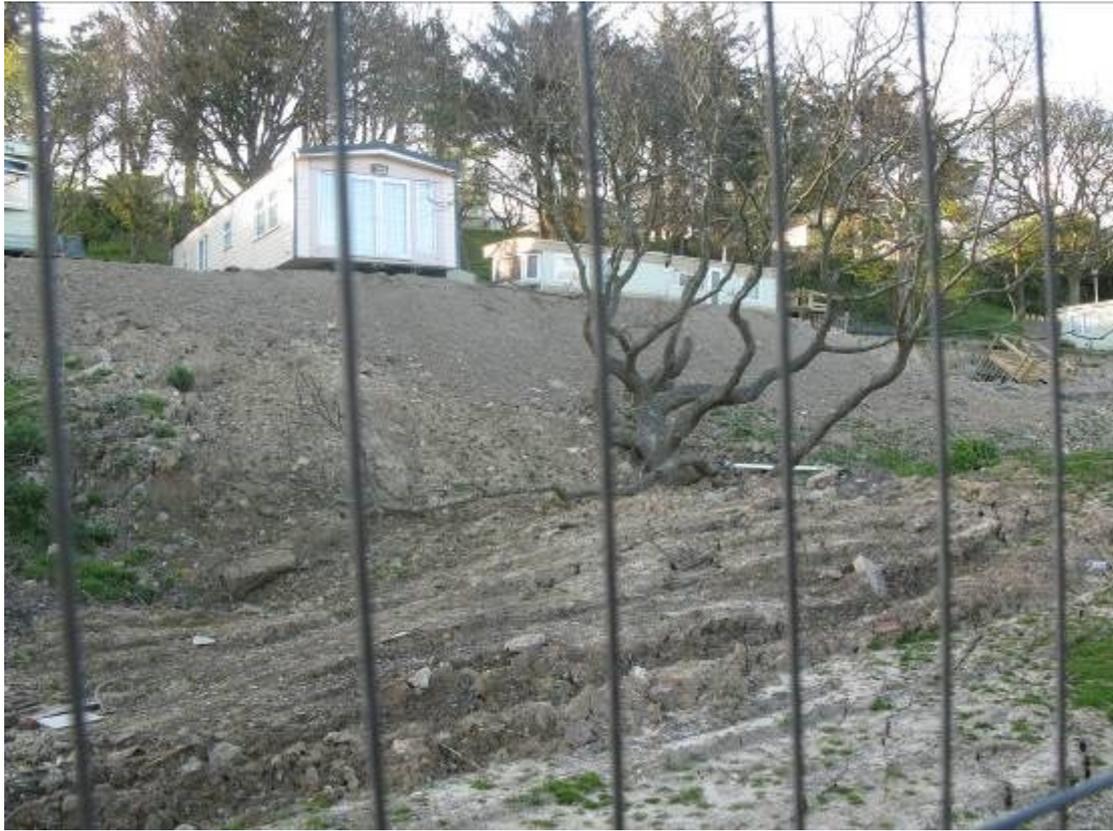
Extensive Terracing in front of new caravans. Just above start of landslip.

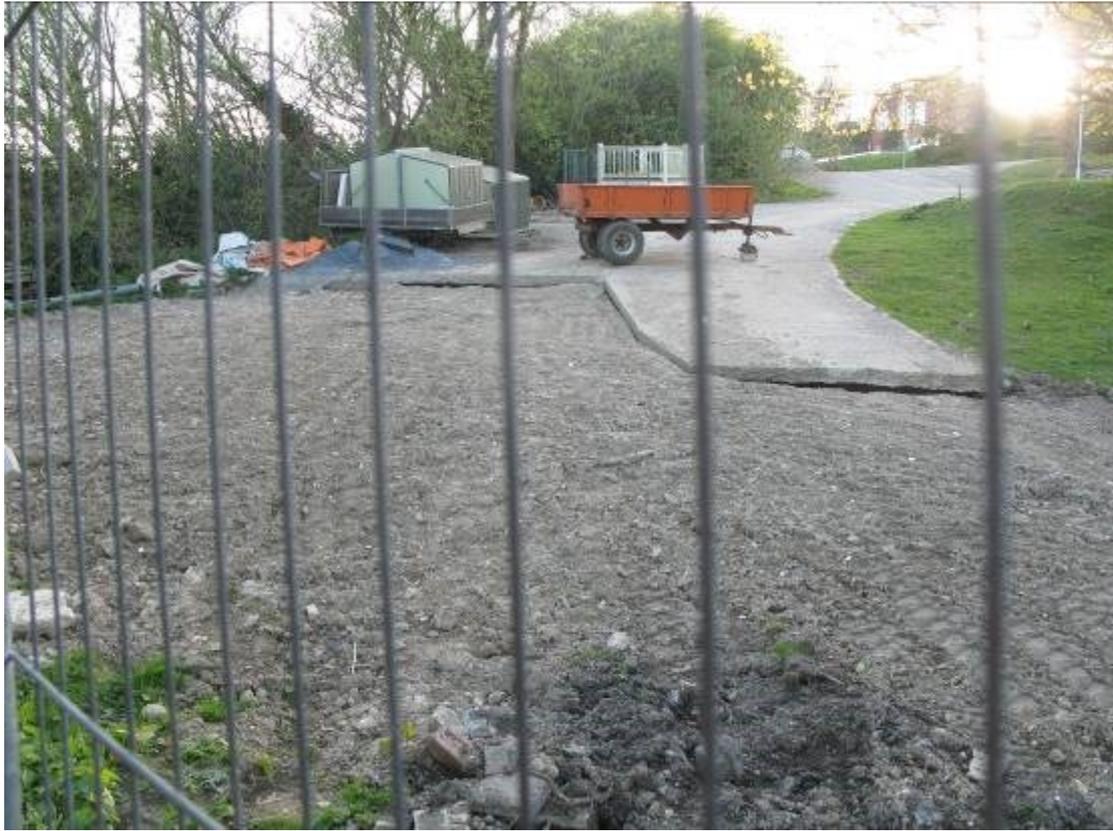
Eastern Link road. Note it is double width with the last part still single.  
The land in the foreground has been cleared to extend the road.  
This ends just above the landslip.
