## **Rocklands Site - Evidence of Tree Removals**

The purpose of this document is to document the programme of tree removals at Rocklands caravan site since 1999 using aerial photos.

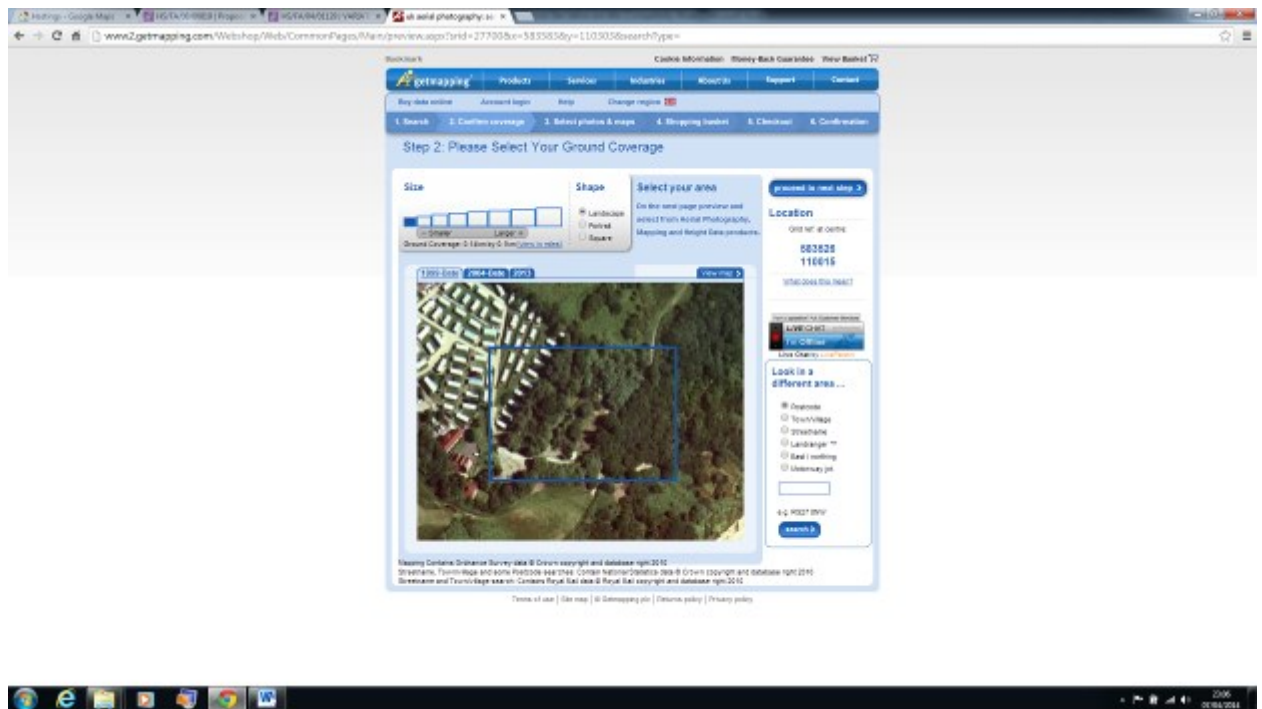
## 1999 GetMapping View

From this image can be seen:

- Dense screening of trees and bushes on the South Western periphery. This screening completely hides any buildings from view when on the East Hill.
- Dense screening of trees and bushes on the Southern and South Eastern peripheries. This screening completely hides any buildings from view when on the far side of Ecclesbourne Glen.
- Screening of trees and bushes on the North East periphery. This screening completely hides the caravans from view when in the meadow that runs parallel to Barley Lane.
- The area to the East and South East of the 10 s and East/North East of the triangular car park is densely planted. There are 3 separate rows of trees, bushes and a small grassed area. This area screens the caravans and top of the site from views anywhere in Ecclesbourne Glen.

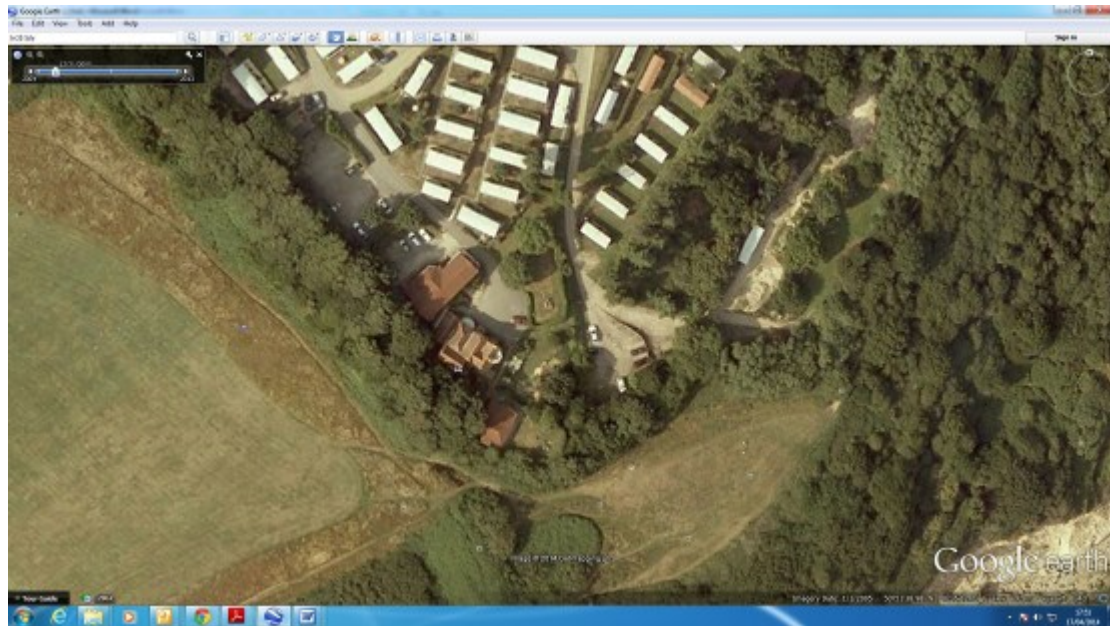
## 2005 Google Earth View

From this image it can be seen:

- The bare strip to the North East of the car park has been extended in length by about 30%.
- A caravan has been installed on this lower strip.

I believe that:

- The installation of the caravan breaches condition 7 of HS/FA/78/00703
- The removal of trees breaches condition 4 of HS/FA/78/00703
- Failure to maintain landscaping breaches condition 8 of HS/FA/78/00703

These changes have had the following visual impact on the Country Park:

- Removal of trees in the bare strip has reduced shielding when viewed from Ecclesbourne Glen

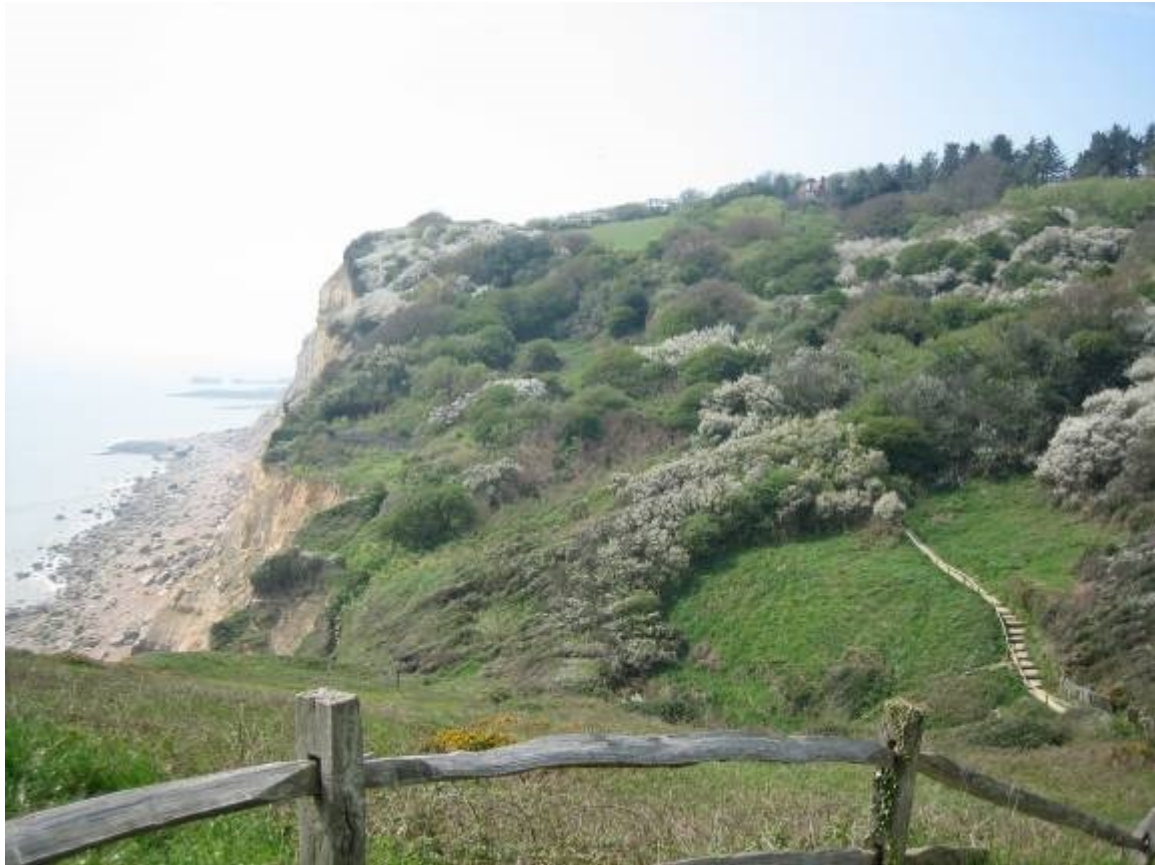
### **View from Ecclesbourne Cliffs Before**

This clearly shows how the trees used to screen the Caravan Site. (May 2006 from wikitravel)

The site is very well screened. And does not impact visually on the glen.  
There is a partial view of the old house.  
No terracing and no caravans at lower level.

This is essentially the view I remember from the early 1960's onwards until the clearances shown in the 2009 aerial photos.

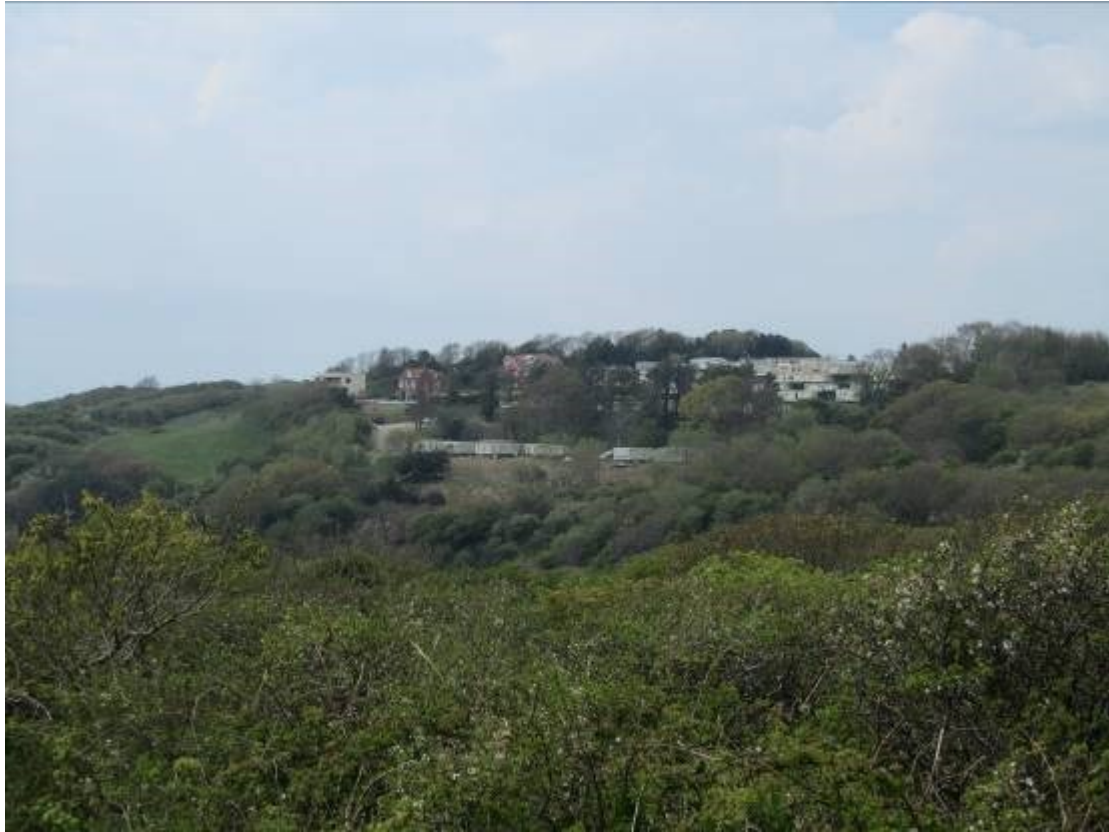
## View from Ecclesbourne Cliffs After

Complete removal of trees for new row of caravans.  
Thinning of evergreens by the old house.  
Thinning of evergreens in front of the 10 caravans installed in 1978.  
New apartment building ,car park and access road fully visible.  
Screening around old house has been removed.  
New 2 storey building is also visible from here.  
The landslip starts at the end of the new access road.
